On Tuesday, January 22, 2019, a P3 paraglider pilot crashed near Hugeroncito, Colombia. He sustained a head injury after his reserve parachute rigging failed. This is a 'Lessons Learned' report.

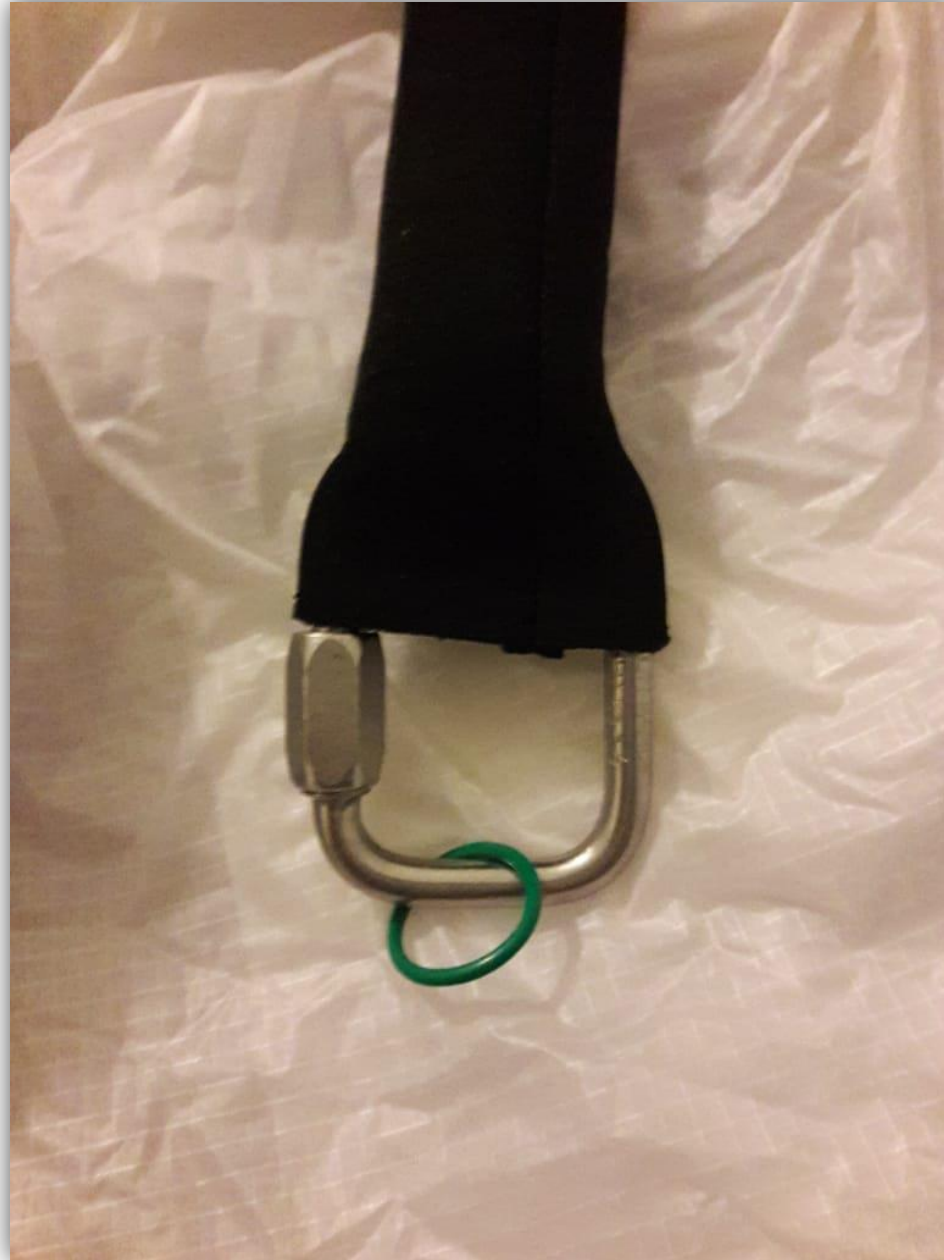
After the gear was verified dry, the pilot began installing the reserve. It was during the reserve bridle attachment procedure when the incident pilot became conflicted on the correct attachment. He was confused by the rubber band keeper-connection to the mallion. (The rubber O-rings used to stop the riser from sliding on the steel mallion).

This author made a radio broadcast “Reserve, Reserve, Reserve”. The injured pilot released his right hand from the control toggle and immediately grabbed the reserve handle. He executed a text-book ‘look-reach-pull-throw’. The deployment handle and bag were aggressively tossed/thrown upwards and away from the wing to an unobstructed area of airspace. Unfortunately, at the moment when the deployment/diaper bag should normally open, the reserve bridle disconnected/exited the harness, unattached. The reserve fell to the earth inside the deployment bag most of the way down to terrain. (The parachute eventually fell out of the deployment bag before it hit the ground.)

**This is how the harness bridle was found. The reserve bridle was never connected.**

- Be disciplined with a safety practice that includes a 'buddy-check' after any modification or adjustment to a flight critical component.
- During the pre-flight check, if ever interrupted at any time, start the entire process over and begin again at step 1.
- Fly with a trauma kit. Unprepared rescuers can use it to save you or, you can use it on another person.
- Regardless of where you fly, always carry personal medical information (allergies, blood type, etc..) and emergency contact information.
- When the emergency chute did not properly deploy, it was the robust helmet that prevented death. (Is your brain bucket certified and robust or, did you opt for something simple that only passes as a 'helmet'?)
