## Michael Lange

For everyone that ever wanted to know what Vittorazi spends 10 hours doing to each carburetor they installed on a Moster 185.

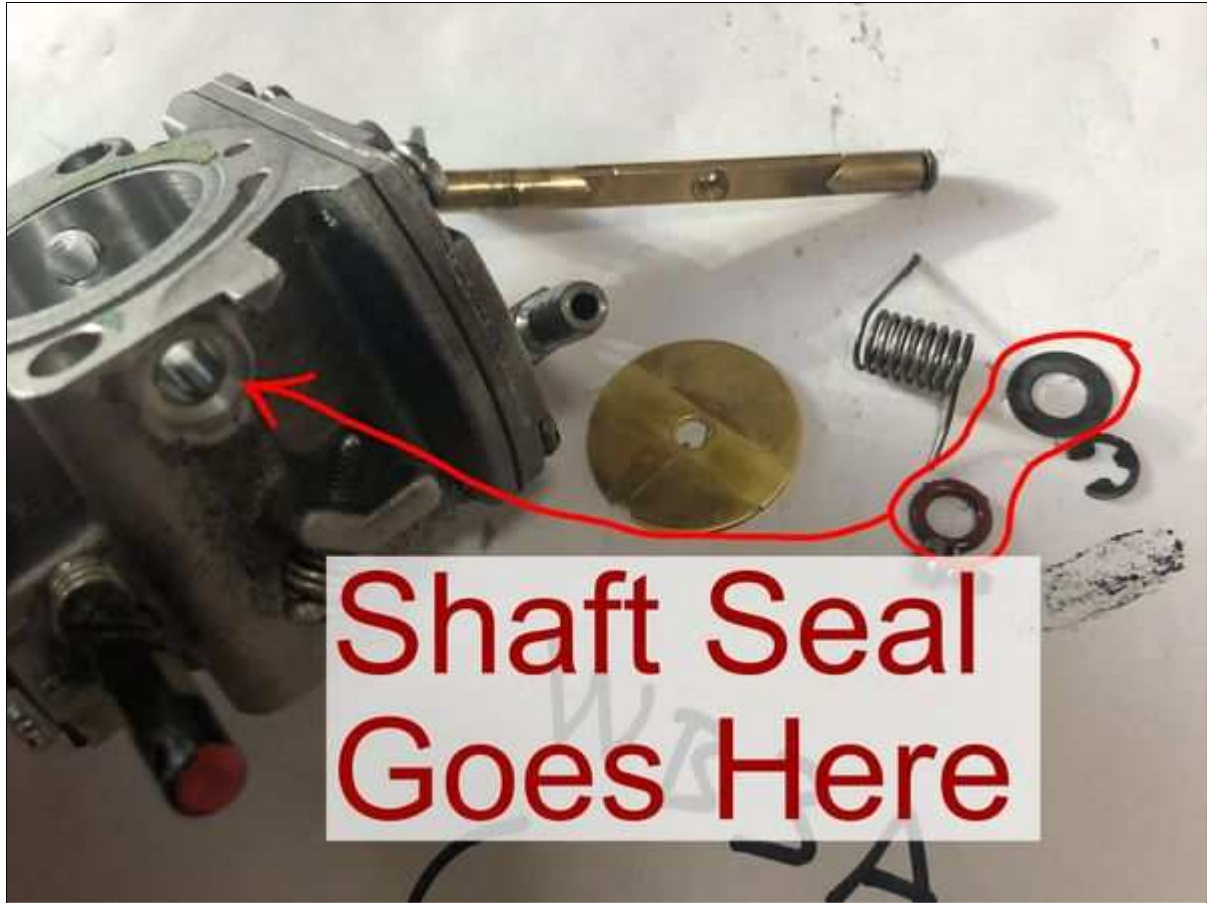
My prognosis of the situation is that the CNC'd shaft seal wore out and air was getting into my carb. If you look close at the shaft, it's not smooth anymore. Do I think this addition is worth it. Probably not in my opinion. The carb is going to wear out and I don't think that additional seal helped it last any longer. Plus, it's not sealed on the other end. In the end the rubber o-ring was damaged, which is probably no worse than the shaft wearing out.

**Shaft Seal  
Goes Here**

I guess the bottom line is, if you get around the 75 hour mark or more and start to have issues you can't resolve easily, get a new carb and be done with it. I paid \$130 for a new Walbro factory carb.

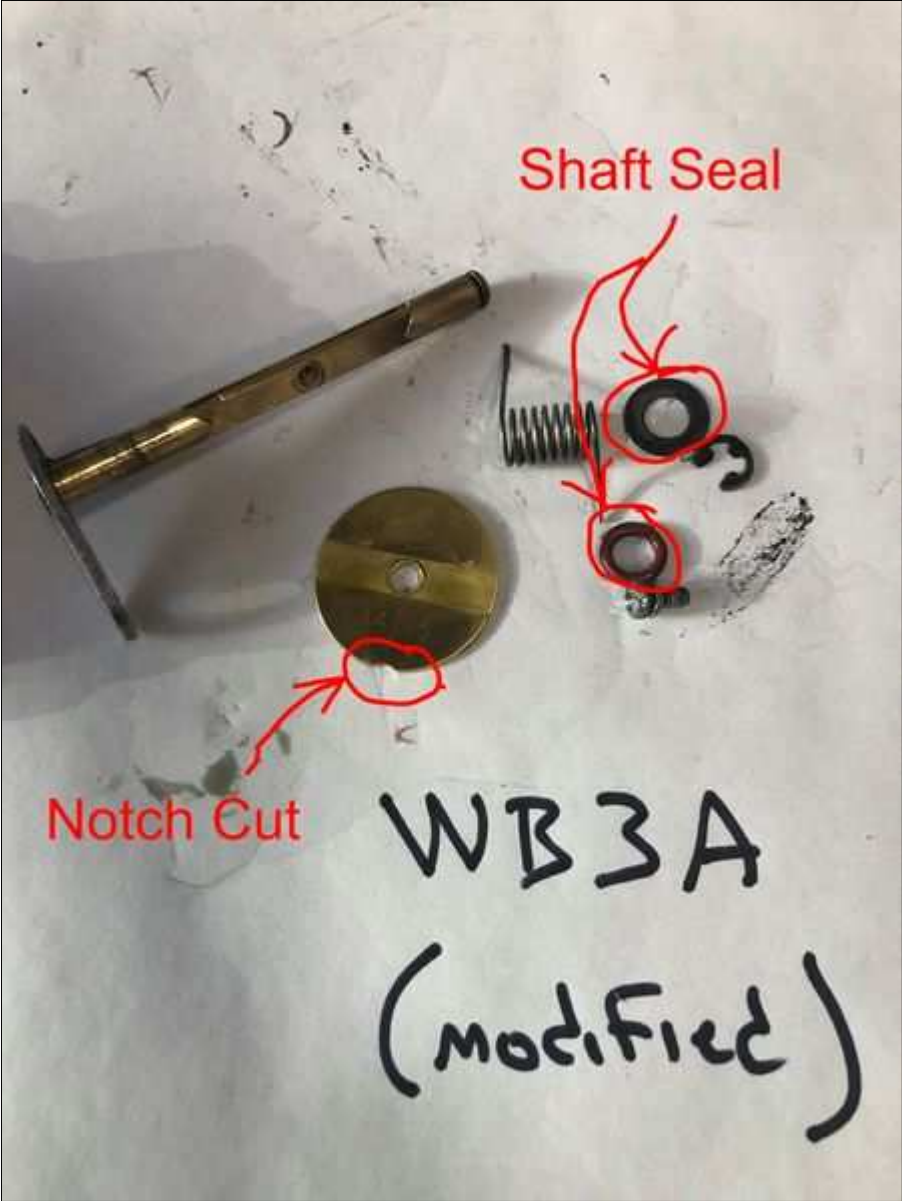
WB3A  
(modified)

Shaft Seal

Notch Cut
