TOP80 Reduction gearbox overhaul by [M.Kubisch](#) - 18th Feb 2008

Introduction

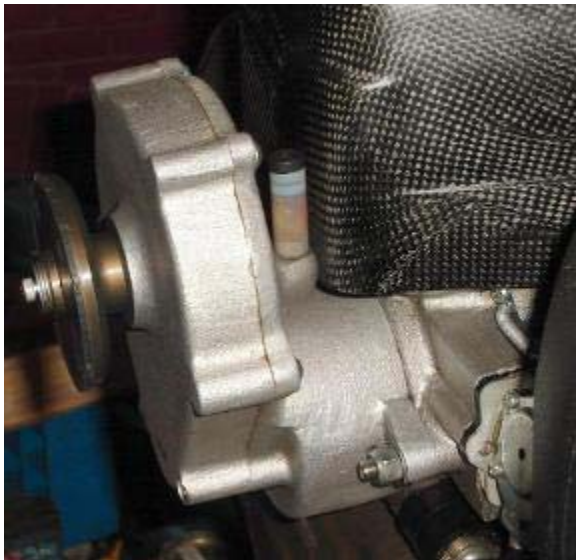
- 1) This is what the reduction box looks like prior to removal. Note the 3 thick washers under the prop hub hold down bolt. Remove the bolt and washers. Remove the nuts on either side of the clutch housing and take the whole re-drive unit off.

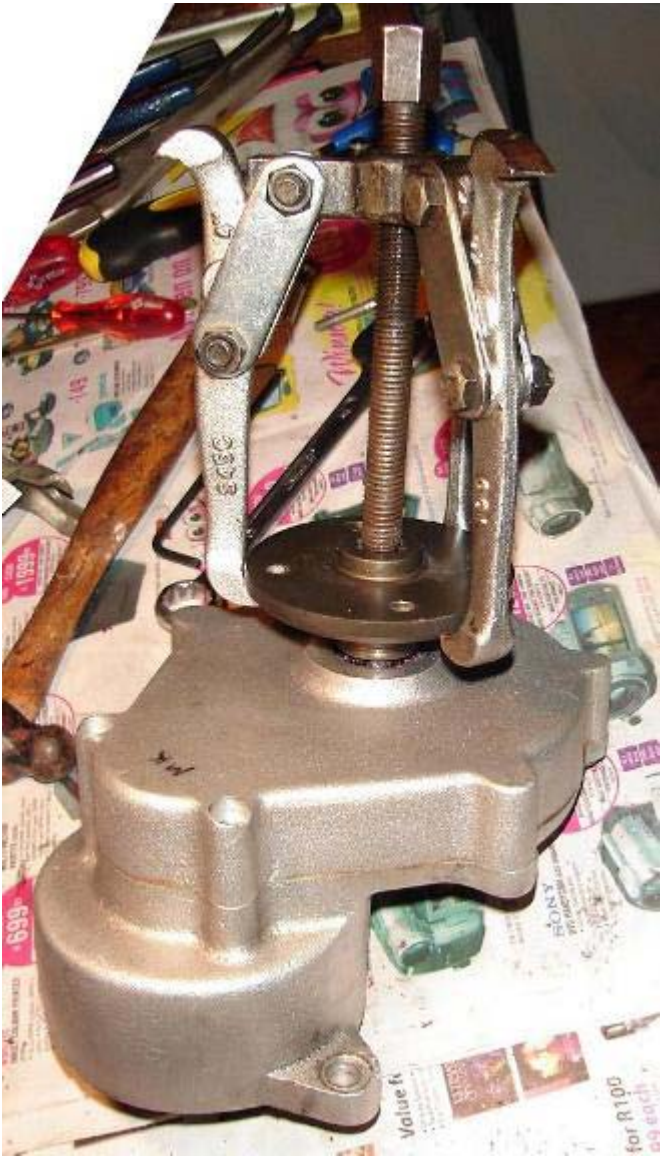
- 2) Use a puller to remove the prop flange.

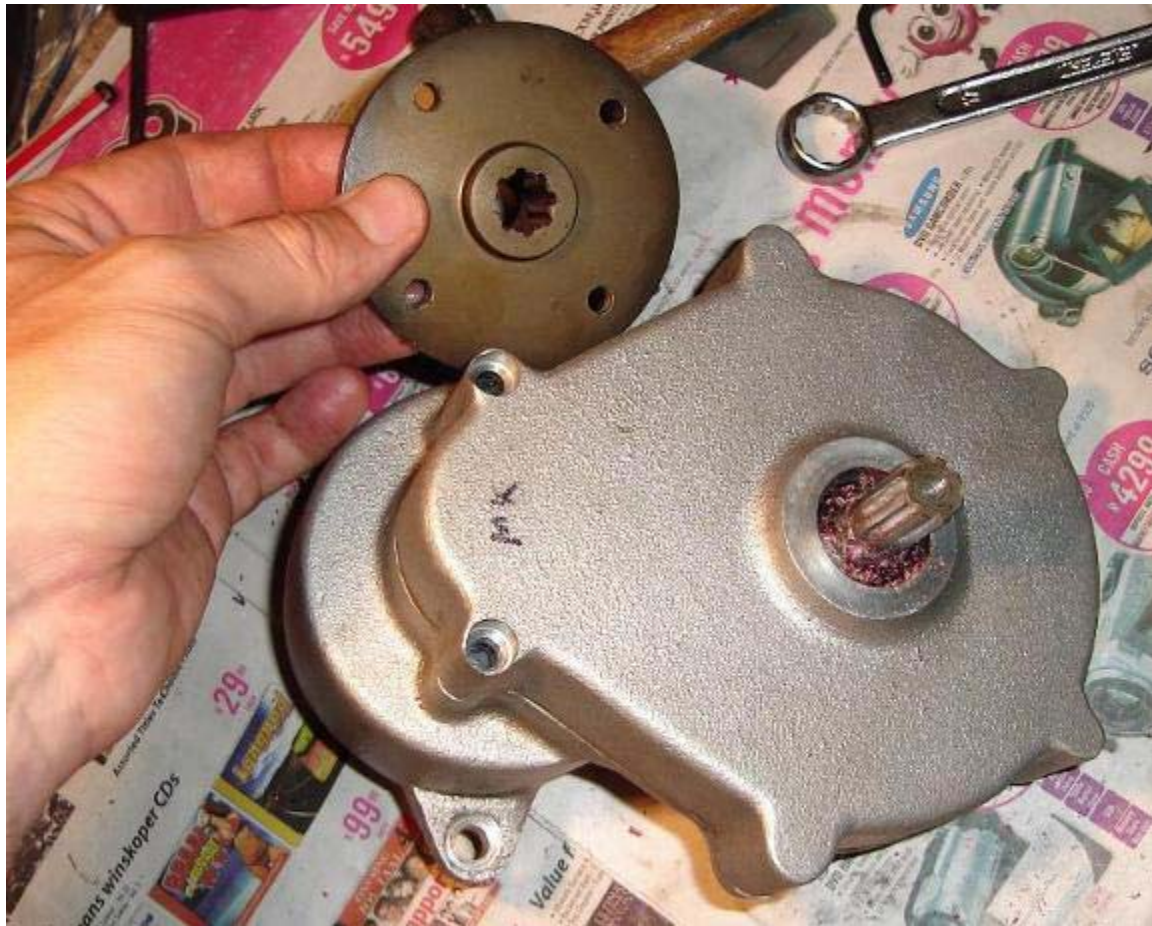
- 3) Here you can see the undamaged mating surfaces between hub and shaft. The red flakes around the shaft are thread-lock shavings, which had to be meticulously cleaned off. I don't recommend applying thread-lock in this way unless you have a badly fitting hub due to previous wear. Note my initials on the box, just in case I forget whose it is!! I think having to mark my schoolbooks and lunchboxes may have affected me for life!!

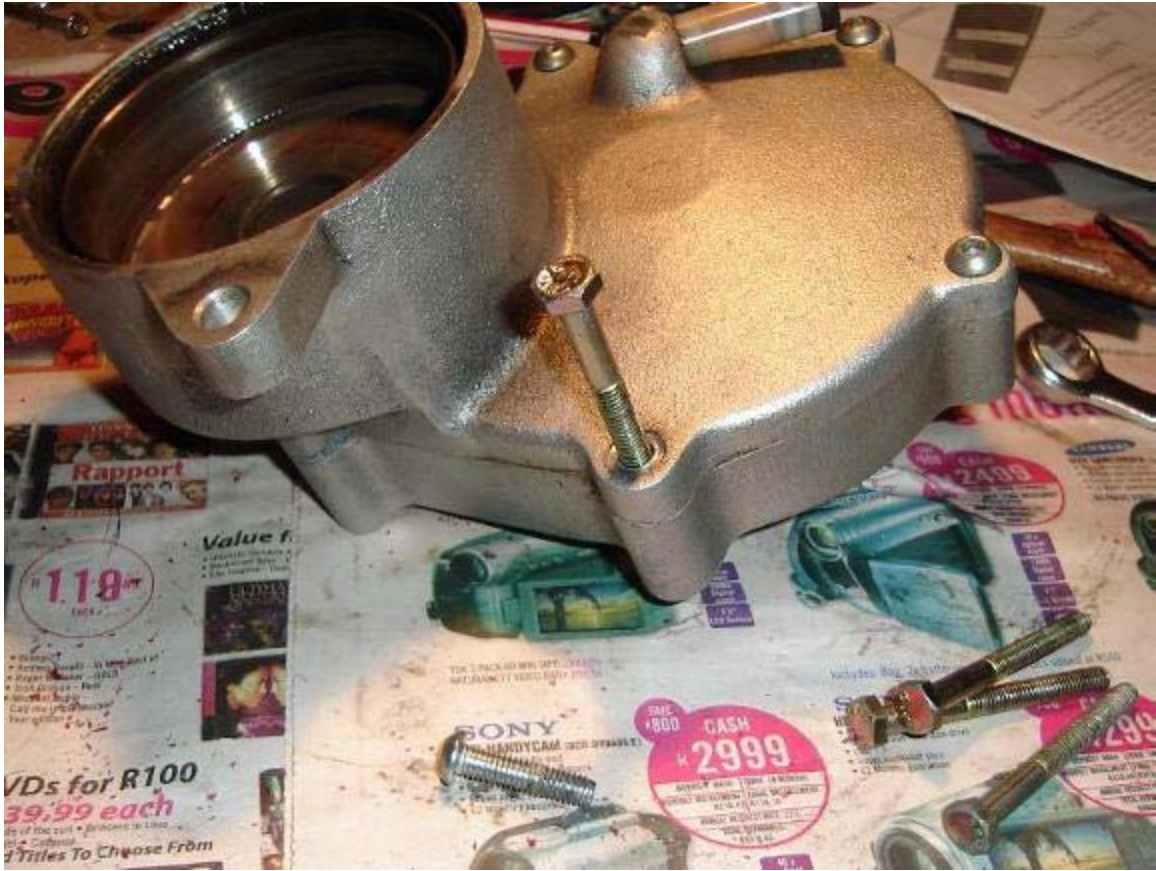
- 4) Here we are fitting the four long bolts, which will allow us to separate the two halves of the case. Note the excessive grease oozing past the clutch bell, one of the reasons why I decided to change out the bearings. The double set of clutch bell side bearings contained rubber seals on one of the bearings only (the outermost one). I'm leaving all seals in place to stop this leakage on the new clutch shaft bearings. There should not be a problem doing this, as the bearings are supposedly pre-lubed for life. Any leakage out of the clutch bell side should be matched by leakage in from the gearbox side, resisted by four seals rather than just two. Time will tell if this is an improvement. Oh look! I see that video cameras are much cheaper than in days gone by, time to upgrade my old SVHS!!

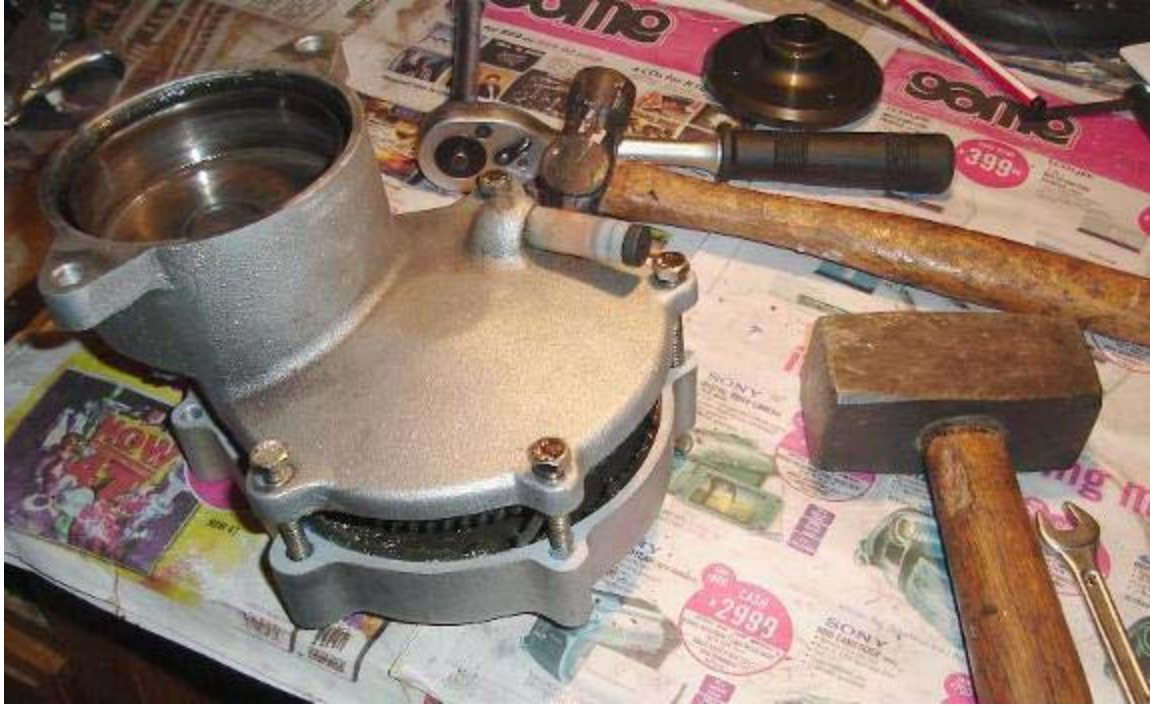
- 5) The four bolts in place, screwed in as far as possible for maximum thread contact. Don't force them in too far and strip the threads though. Supporting the box by the clutch (i.e. Suspending the lower part of the box in the air) tap down successively on each of the four bolts gently to break the seal and separate the case. This should pop apart fairly easily once the seal is broken.

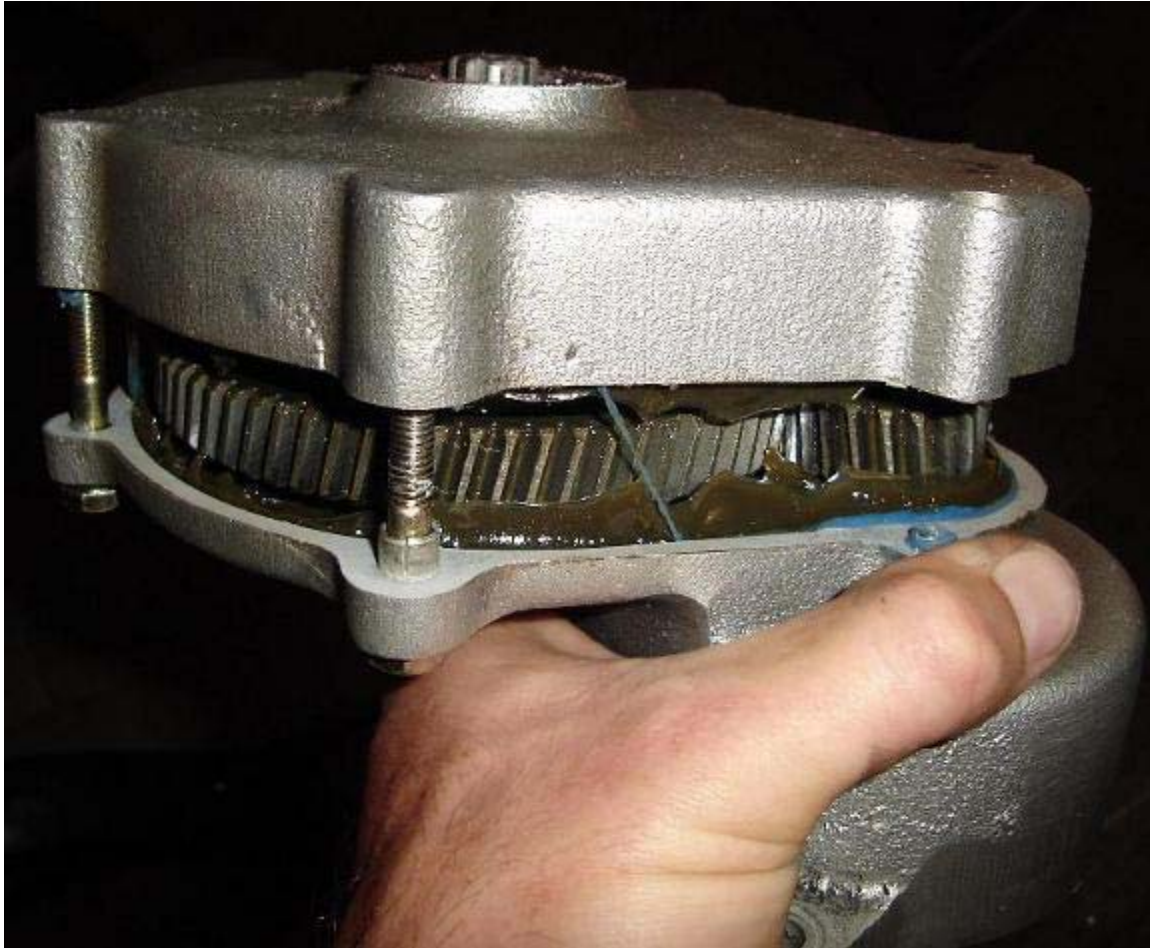
- 6) Here, the bolts have been tapped through to their maximum extent and can be removed. The old grease can be seen, still fairly clean, to be expected on a low hours box. Looks like a blue silicone based sealant was used previously see the stringy bit still clinging on between each half of the case. It did the job; I had no leaks along the join.

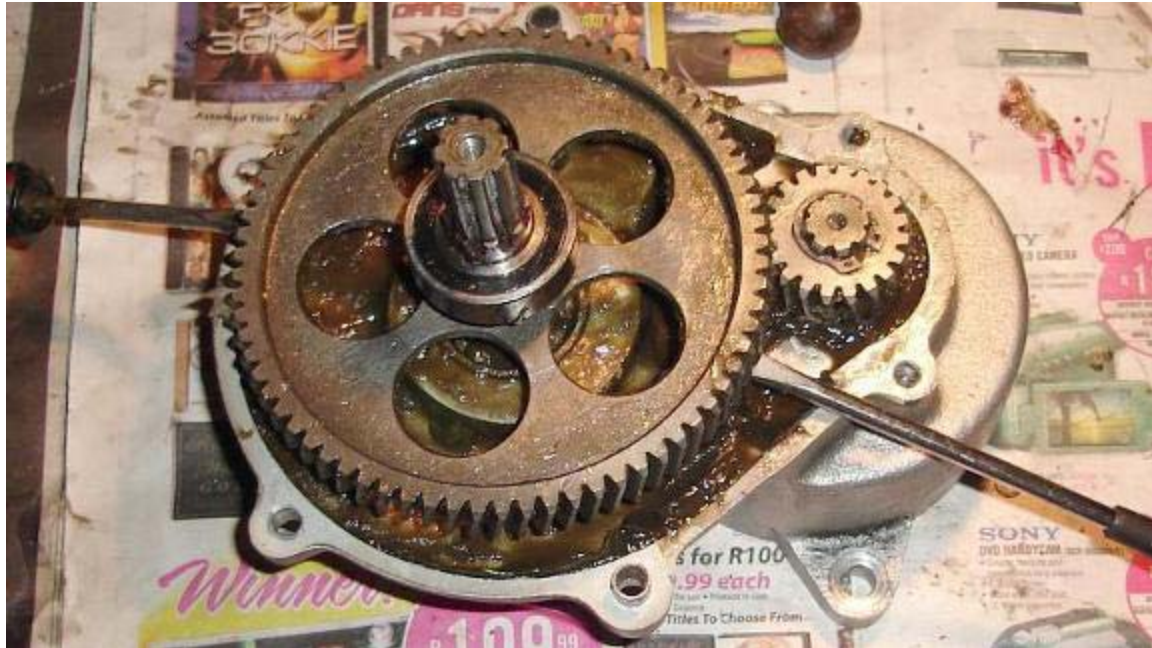
- 7) Using two large screwdrivers as levers, the main gear can be levered out. Be careful not to damage the mating surfaces with the screwdrivers. It should pop out fairly easily. If not, make sure that the force is applied evenly to each side and use pieces of wood to lever against to protect the case.

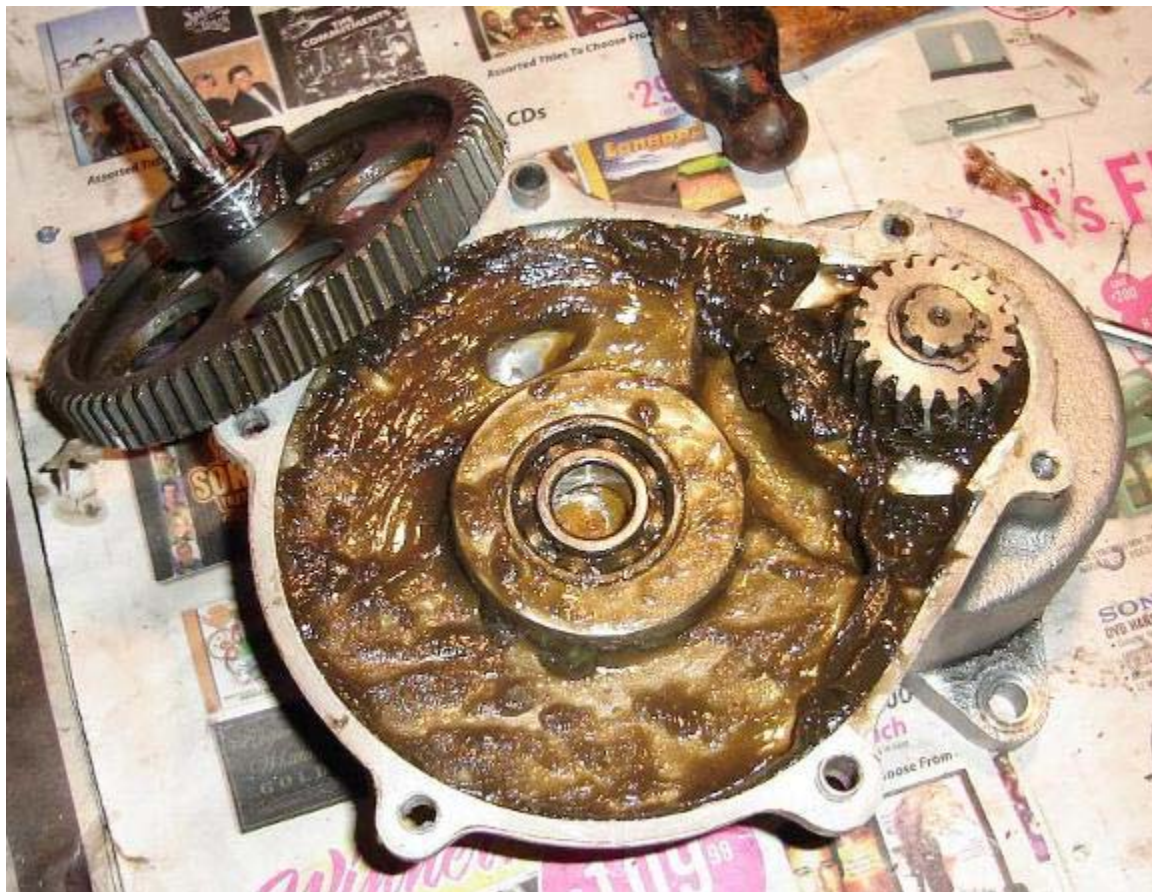
- 8) The fun part, cleaning out all the old grease! Remove the circlip from the small pinion so long.

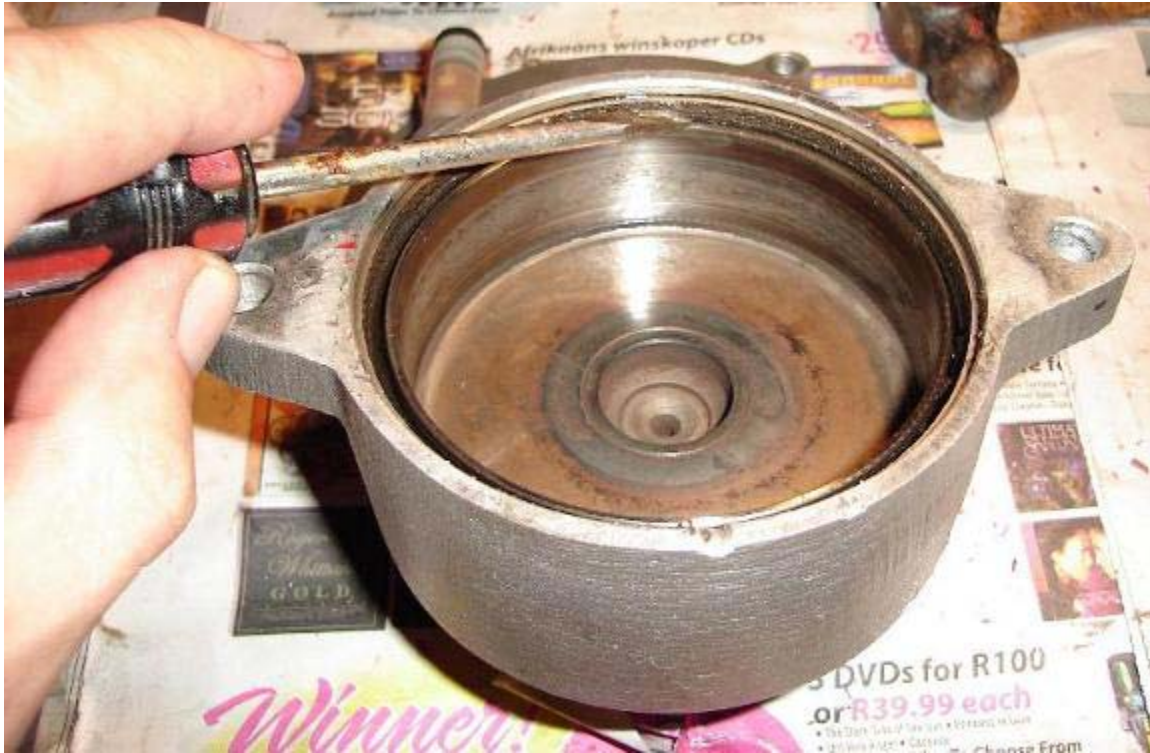
- 9) Scribe a line along the top of the clutch bell against the casing. This will indicate how far the bell/shaft needs to be driven in on reassembly. Note the small groove in the lower casing flange to let the excess grease ooze out. It will be an easy inspection point to monitor the new bearing's grease retention in future too.

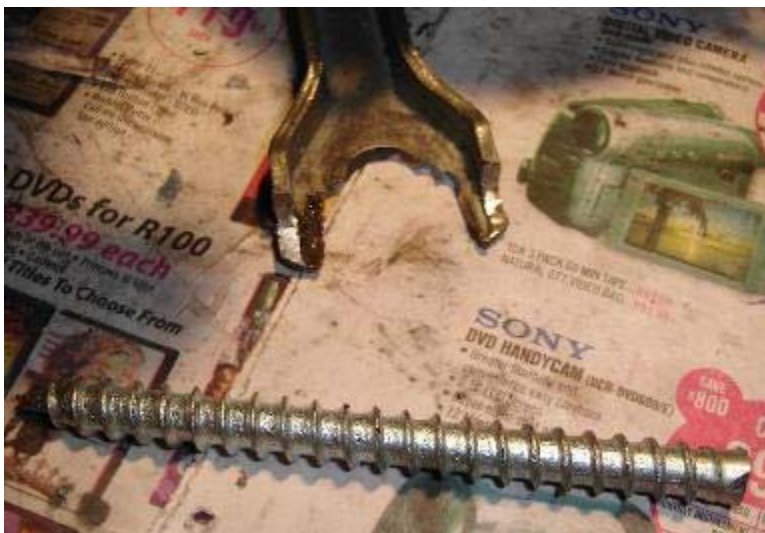
- 10) Here are two parts I had to modify (using a small angle grinder) to allow removal of the small pinion. The top part is the end of a valve removal tool; the lower is a coach bolt with its head removed.

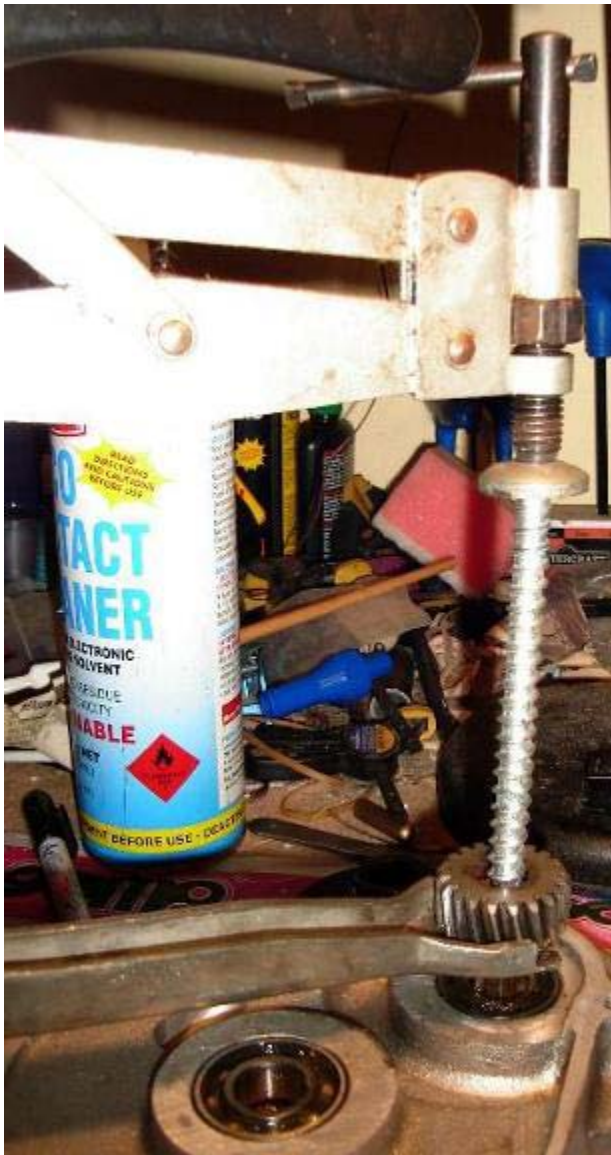
11) Here is the custom tool in action. Make sure to remove the circlip first! Before doing it this way, I had tried to lever the pinion off but without success. Your mileage may vary so perhaps try levering it off first, just don't damage the soft aluminum mating surfaces. Now drive the shaft out through the two supporting bearings being careful to support the edges of the clutch housing but allow room for the bell to exit the housing. This was quite tight and took many blows with the large hammer. I really thought I was going to break something, but that casing is tougher than it looks.

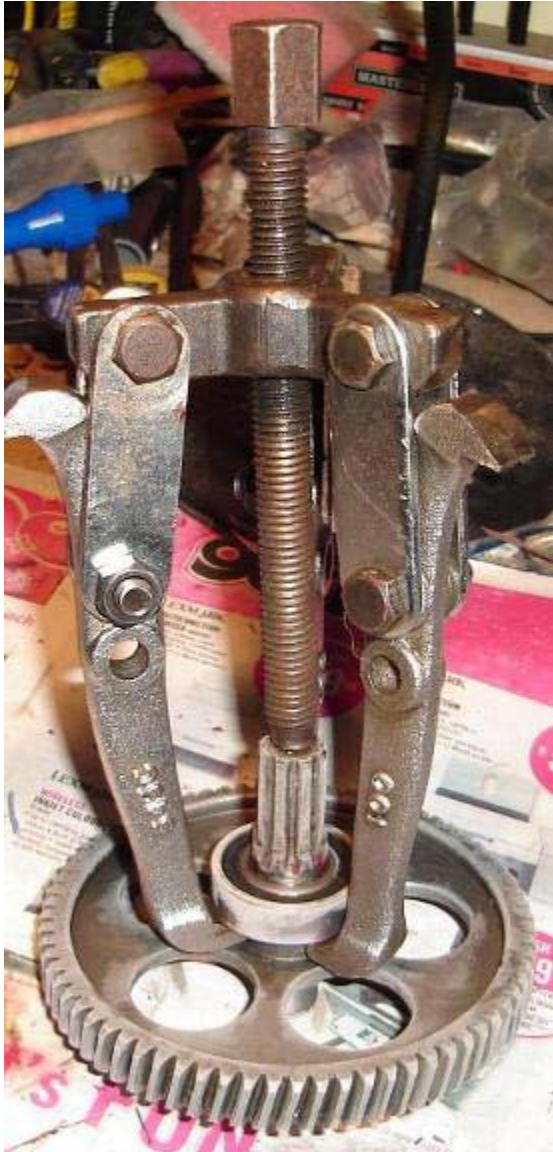
12) Just look at that cool frosty finish on the main gear, makes me want to reach into the fridge for a cool one.... The gear spent an hour or so in the freezer to cool it down. I then warmed the bearing with a mini blowtorch to maximize the temperature differential (and therefore clearance) prior to pulling the bearing off. It was quite tight. I don't think you would be able to lever this one off without the correct tool. Drive a new bearing on

the still chilled shaft using a drift contacting the centre of the bearing only. I seem to remember using a spark plug socket.

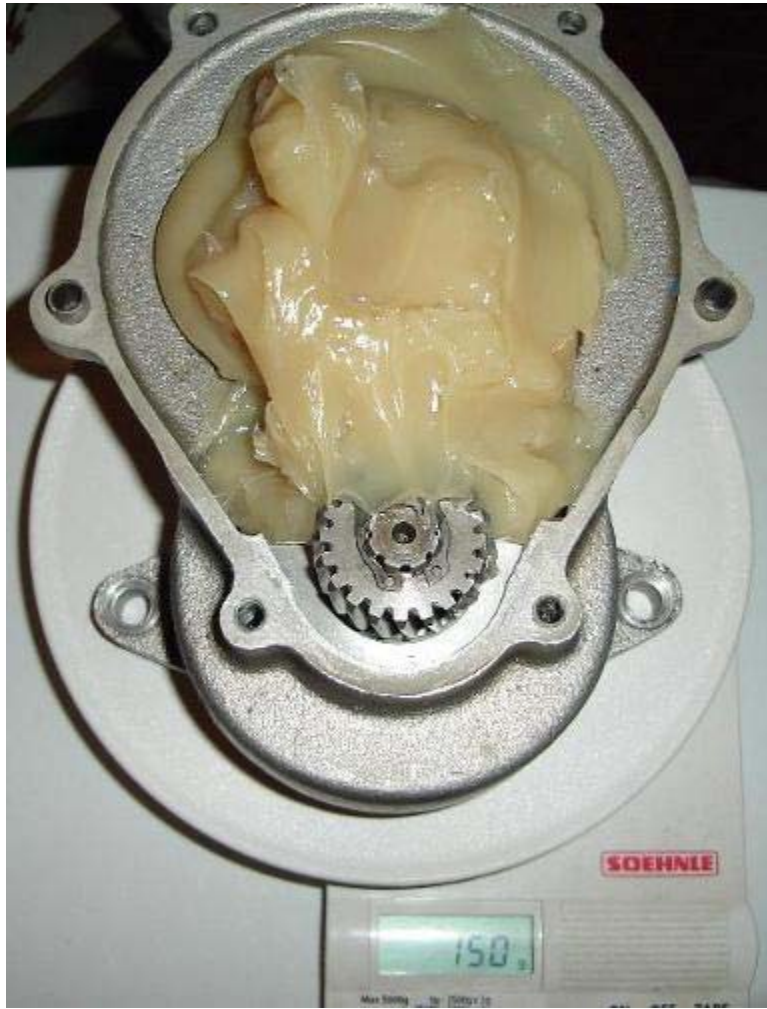
- 13) Ok we have jumped ahead a bit here, the old bearings have been removed by heating the case in the oven to 150 degrees C, and then using oven mitts, bang out both the clutch bearings and the single prop shaft bearing onto the kitchen table (protective covering advised). New bearings from the freezer can be popped in at the same time but be sure to keep them cool to avoid damaging the seals. The seals should be removed from the rear prop shaft bearing first. (This is the only one you need to remove seals from). Drive the (chilled) clutch bell/shaft back into place (up to the mark previously scribed in the bell housing) once the bearings have reached room temperature again. Refit the small pinion and circlip. Now measure out 150g of standard lithium based grease (e.g. Castrol LM). I used a scale (see below) zeroed (press Tare button) with the weight of the box on it, then add grease to the 150g mark.

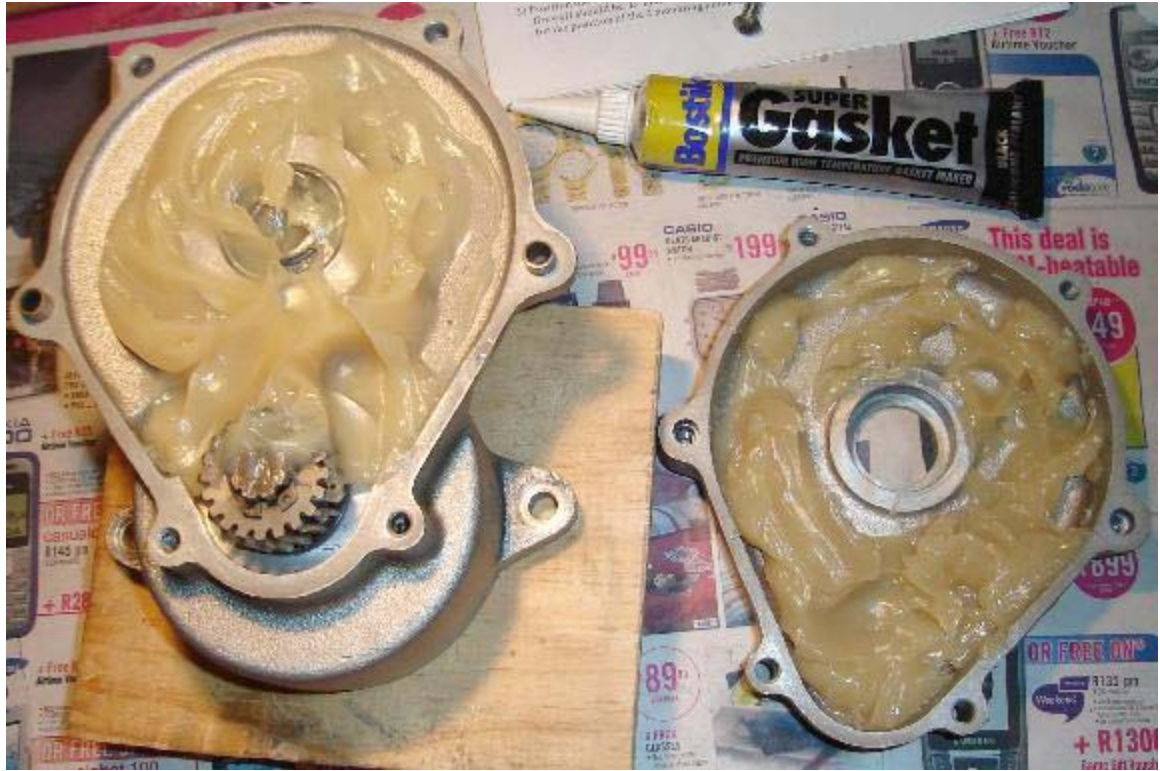
14) Probably unnecessary, but I distributed the grease between the two halves. Don't get it in the bearing seat (right side cover) or it could promote bearing spin in the housing. See the brand of sealant I used in the picture below, it's a black silicone based sealant.

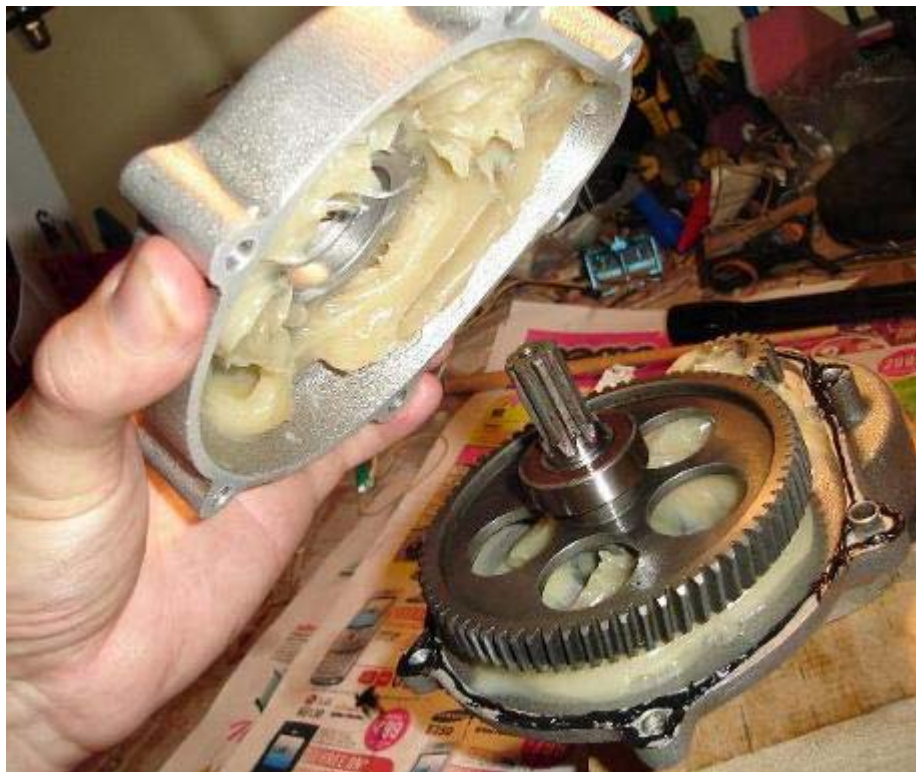
15) A thin bead of sealant has been applied to the mating surfaces and the two halves are brought together. If your prop-shaft output bearing was subject to spinning in it's housing, apply thread-locker compound around the seat area first.

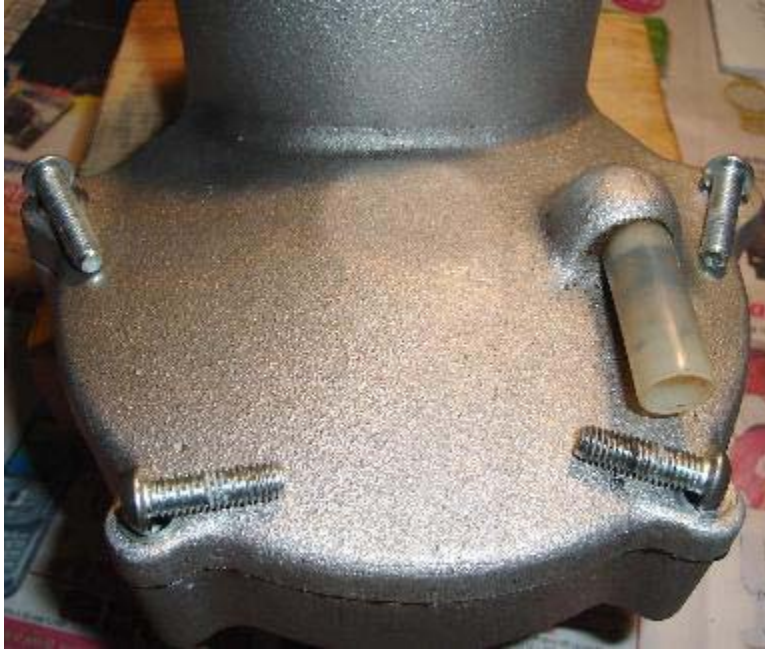
16) Note that the two shorter screws are closer in the picture below. Note the missing black vent cap cover, it melted in the oven, oops!! (I have since procured a toothpaste cap drilled 1.5mm in the centre, hot glued on, which is working admirably so far).

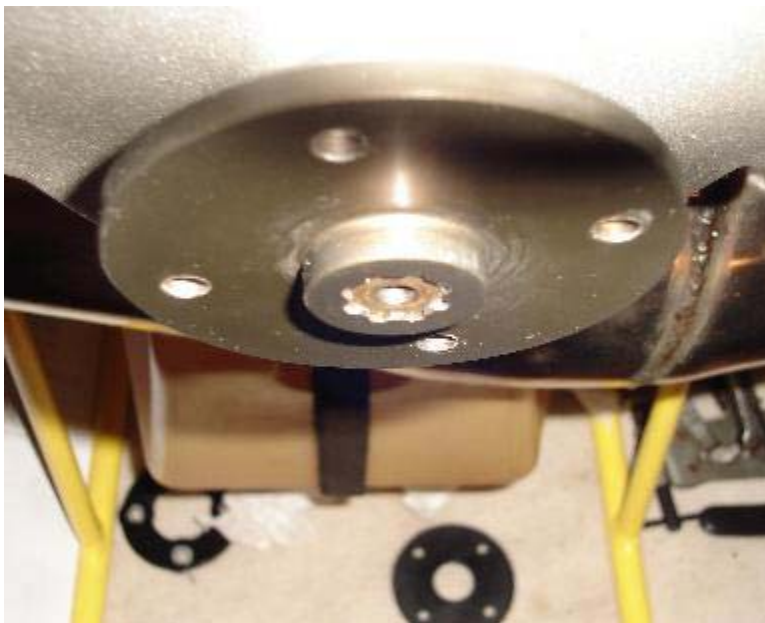
17) Refit the box and drift on the prop hub, making sure the shaft and hub contact surfaces are spotless. There should be no rocking and the shaft should sit in 1-2mm as shown in the picture below to allow the retaining bolt to draw down. Apply a little thread-locking compound to the screw and tighten up, using 2-3 thick washers. Be careful not to bottom the screw if it's too long.
