On Tuesday, January 22, 2019, a P3 paraglider pilot crashed near Hugeroncito, Colombia. He sustained a head injury after his reserve parachute rigging failed. This is a 'Lessons Learned' report.

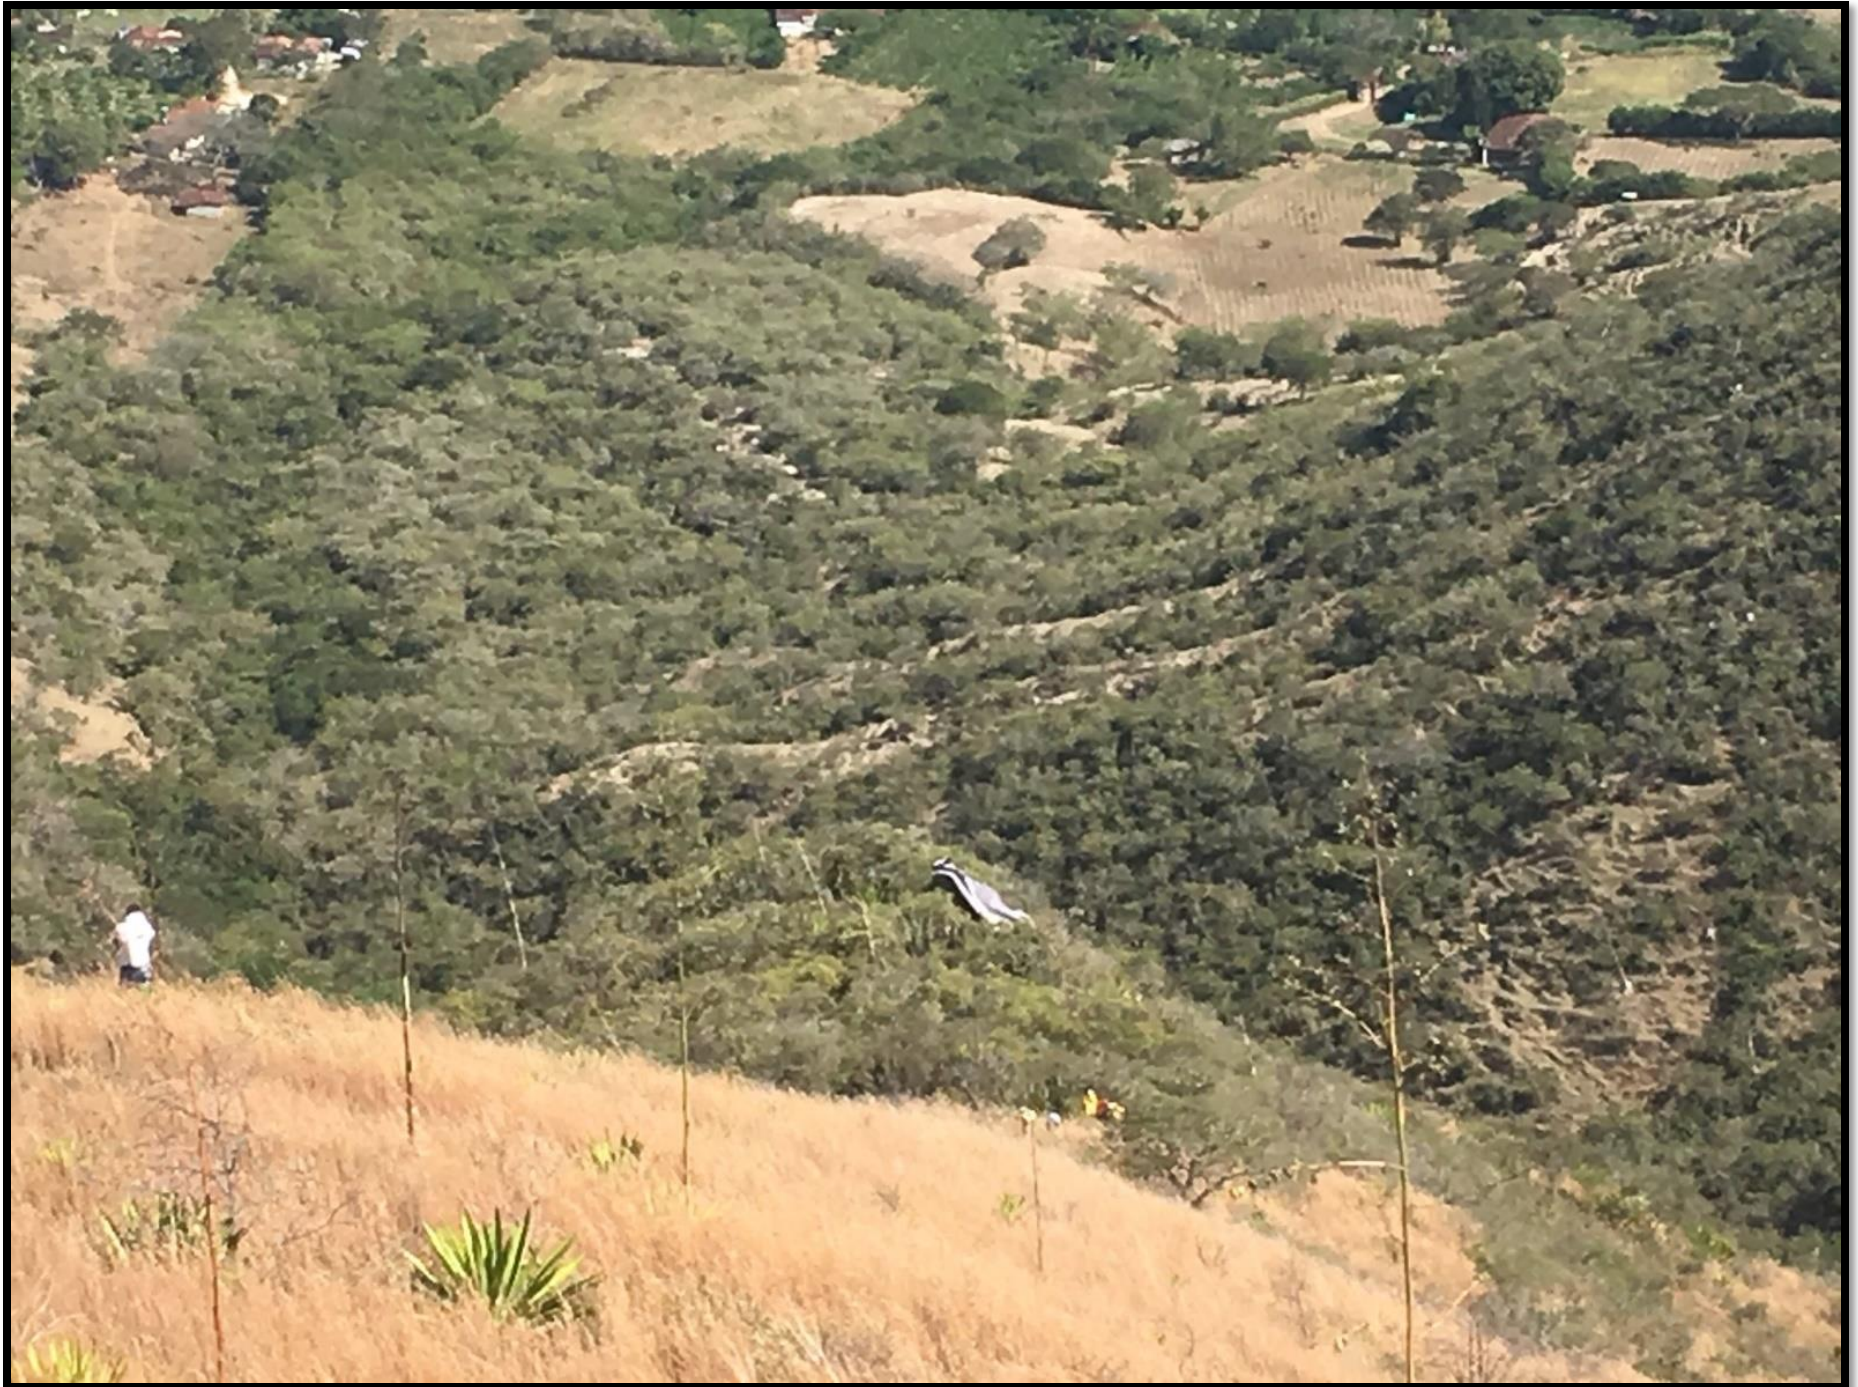
**This is how the harness bridle was found. The reserve bridle was never connected.**

- Be disciplined with a safety practice that includes a 'buddy-check' after any modification or adjustment to a flight critical component.
- During the pre-flight check, if ever interrupted at any time, start the entire process over and begin again at step 1.
- Fly with a trauma kit. Unprepared rescuers can use it to save you or, you can use it on another person.
- Regardless of where you fly, always carry personal medical information (allergies, blood type, etc..) and emergency contact information.
- When the emergency chute did not properly deploy, it was the robust helmet that prevented death. (Is your brain bucket certified and robust or, did you opt for something simple that only passes as a 'helmet'?)
