## Michael Lange

For everyone that ever wanted to know what Vittorazi spends 10 hours doing to each carburetor they installed on a Moster 185.

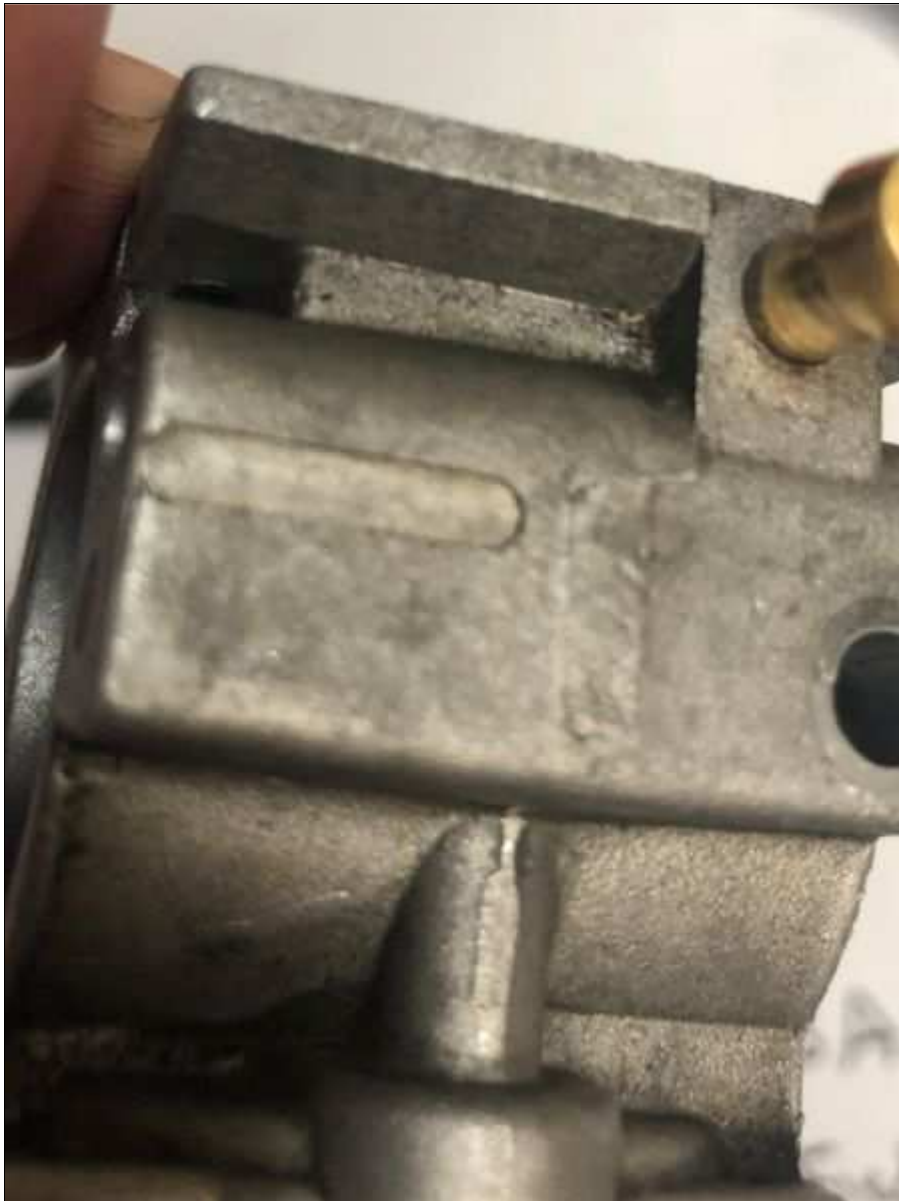
1. They CNC off the model name of the carburetor from the side. See photo.
2. They cut a notch in the butterfly valve just over the fuel jets. See photo.
3. They CNC a recessed shoulder where the butterfly valve shaft enters the carburetor on the linkage side, and then install a rubber O-ring and place a washer over the top held in by the linkage spring.
4. They drill an extra fuel hole into the carburetor at an angle. See the two photos below.

Now for my opinion (which is what it is, and therefore is up for debate). So I probably got about 125+ hours on this carb. I started noticing problems around the 80 hour mark. At first it showed up as a rough idle and rough running low end. (Experts recommended that I richen the low end.) When I would throttle up, the roughness would go away. It then became increasingly harder to start. I would have to prime the carb good, then hold the throttle open to get it to start. After that, the motor started randomly dying in flight (a few motor outs). Then it would randomly die on the ground when doing a run-up. It finally got to the point where I couldn't keep it running very long.

My prognosis of the situation is that the CNC'd shaft seal wore out and air was getting into my carb. If you look close at the shaft, it's not smooth anymore. Do I think this addition is worth it. Probably not in my opinion. The carb is going to wear out and I don't think that additional seal helped it last any longer. Plus, it's not sealed on the other end. In the end the rubber o-ring was damaged, which is probably no worse than the shaft wearing out.

I bought a stock WB3A, switched the notched butterfly out and installed it on my motor. The motor is back to starting in one pull and seems to run fine at all RPMs. It does seem to wonder at idle ever so slightly, but I can live with that.

I guess the bottom line is, if you get around the 75 hour mark or more and start to have issues you can't resolve easily, get a new carb and be done with it. I paid \$130 for a new Walbro factory carb.
